**Flood Control Project Maintenance
Levee Inspections**
LMA District Cover Sheet
Spring 2019 Levee Inspection Results

Reclamation District No. 2107 Mossdale Island

Levee Inspection Report By Mile - Spring 2019

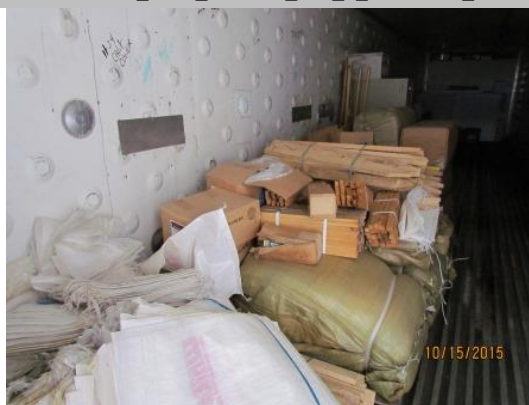
Photo 1 of 1 : SP_2019_RD2107_329_7_20190313_00001.jpg

LM Start		Rating **	A	Issue No.	7
LM End		Issue Type +	Ma	Location *	
Category	Earthen Levee		GPS Latitude/Longitude		
			Start	End	
Item	Emergency Supplies & Equipment				
DWR ID	DWR_RD2107_01_s_2013_7				
Comment Code					
Inspector Comment					
Flood fighting supplies are available on-site.

View of the flood fight emergency supplies.

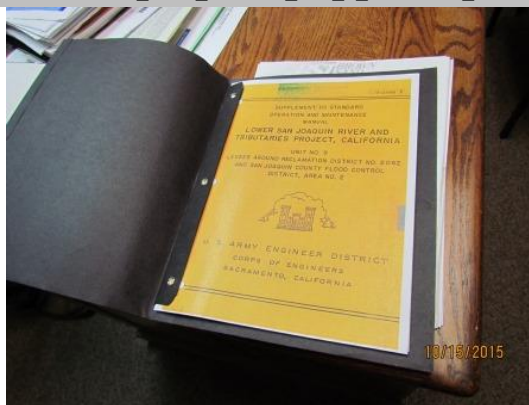
Photo 1 of 1 : SP_2019_RD2107_329_8_20190313_00002.jpg

LM Start		Rating **	A	Issue No.	8
LM End		Issue Type +	Ma	Location *	
Category	Earthen Levee		GPS Latitude/Longitude		
			Start	End	
Item	Operations & Maintenance Manuals				
DWR ID	DWR_RD2107_01_s_2013_8				
Comment Code					
Inspector Comment					
The O&M Manual is available at the LMA's office.

View of the O&M Manual.

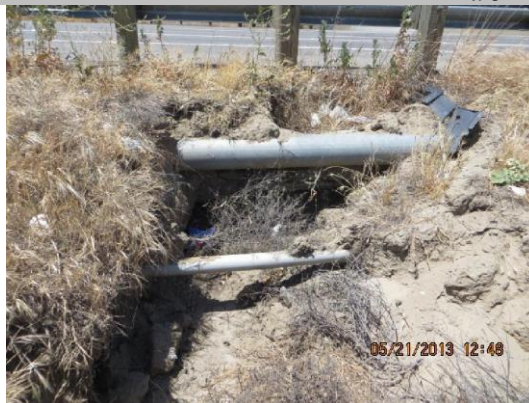
Photo 1 of 1 : UCIP_SP_2019_16187_27294.jpg

LM Start	0.23	Rating **	M	Issue No.	24
LM End	0.23	Issue Type +	En	Location *	
Category	Supplemental			GPS Latitude/Longitude	
				Start	End
Item	DWR UCIP Field Study			37.784586 °	37.784586 °
				-121.306837 °	-121.306837 °
DWR ID	23107				
Comment Code					
Inspector Comment					
FS_ID:16187					
DS_ID:23107					
EP_NO: N/A					
Repair Type: Non-Urgent					
Crossing Status: Found					
UCIP Comments: No permit identified. Erosion exposed pipes on LS.					
FIELD_STRUCT_DESC: 3-inch polyvinyl chloride (PVC) conduit of an unknown purpose, 1 foot below the road surface, within roadway fill over the levee crown.					
FS Date: 5/22/2013

Pipes visible on LS next to roadway.

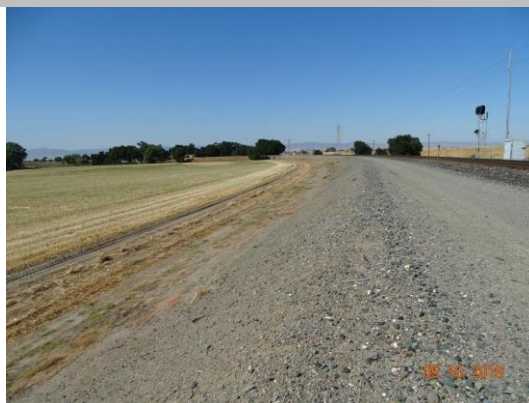
Photo 1 of 1 : SP_2019_RD2107_329_22_20190514_00025.jpg

LM Start	0.23	Rating **	A	Issue No.	22
LM End	2.04	Issue Type +	Ma	Location *	LS
Category	Earthen Levee			GPS Latitude/Longitude	
				Start	End
Item	Vegetation			37.784586 °	37.765040 °
				-121.306837 °	-121.309750 °
DWR ID	DWR_RD2107_01_s_2019_22				
Comment Code					
V1 : Control annual grass and weeds on the levee slopes and easements.					
Inspector Comment					
Annual vegetation is well maintained.

Typical view of vegetation on landside slope. (Spring 2019)

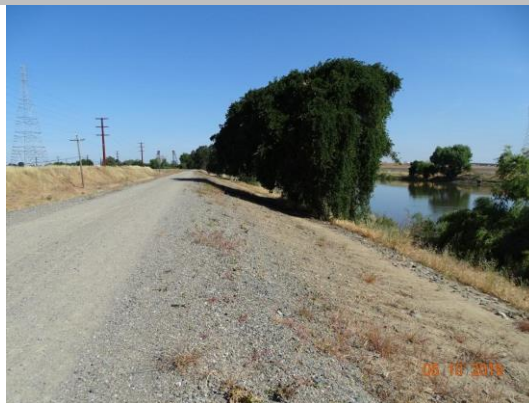
Photo 1 of 1 : SP_2019_RD2107_329_23_20190514_00026.jpg

LM Start	0.23	Rating **	A	Issue No.	23
LM End	2.04	Issue Type +	Ma	Location *	WS
Category	Earthen Levee			GPS Latitude/Longitude	
				Start	End
Item	Vegetation			37.784586 °	37.765040 °
				-121.306837 °	-121.309750 °
DWR ID	DWR_RD2107_01_s_2019_23				
Comment Code					
V1 : Control annual grass and weeds on the levee slopes and easements.					
Inspector Comment					
Annual vegetation is well maintained.

Typical view of vegetation on waterside slope. (Spring 2019)

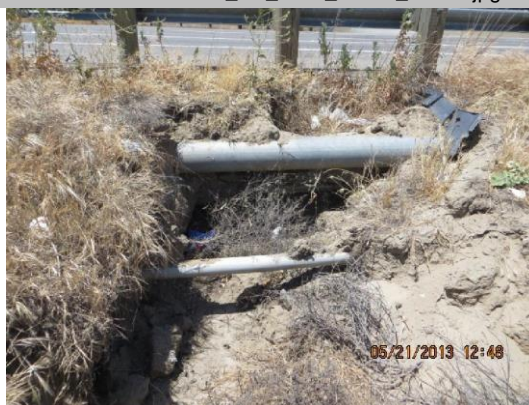
Photo 1 of 1 : UCIP_SP_2019_15175_24922.jpg

LM Start	0.23	Rating **	M	Issue No.	25
LM End	0.23	Issue Type +	En	Location *	
Category	Supplemental			GPS Latitude/Longitude	
				Start	End
Item	DWR UCIP Field Study			37.784586 °	37.784586 °
				-121.306837 °	-121.306837 °
DWR ID	23108				
Comment Code					
Inspector Comment					
FS_ID:15175 DS_ID:23108 EP_NO: N/A Repair Type: Non-Urgent Crossing Status: Found UCIP Comments: No permit identified. Erosion exposed pipes on LS. FIELD_STRUCT_DESC: 8-inch steel conduit of an unknown purpose, 1 foot below the road surface, within roadway fill over the levee crown. Visible on the upstream side of the bridge. FS Date: 5/22/2013

Pipes visible on LS next to roadway.

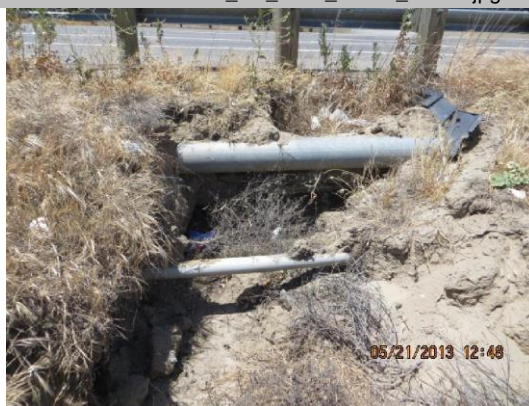
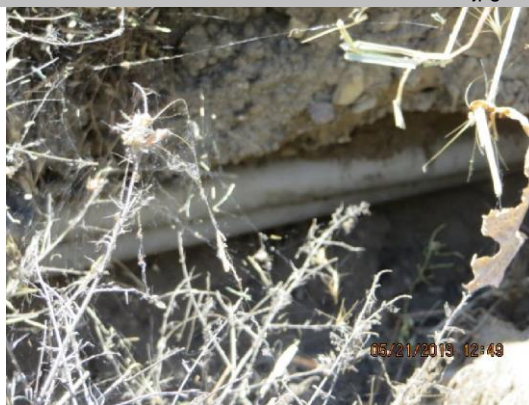
LM Start	0.23	Rating **	M	Issue No.	26
LM End	0.23	Issue Type +	En	Location *	
Category	Supplemental			GPS Latitude/Longitude	
				Start	End
Item	DWR UCIP Field Study			37.784586 °	37.784586 °
				-121.306837 °	-121.306837 °
DWR ID	23109				
Comment Code					
Inspector Comment					
FS_ID:15173					
DS_ID:23109					
EP_NO: N/A					
Repair Type: Non-Urgent					
Crossing Status: Found					
UCIP Comments: No permit identified for this crossing. Erosion exposed pipes on LS.					
FIELD_STRUCT_DESC: 1.5-inch polyvinyl chloride (PVC) conduit of an unknown purpose, 1 foot below the road surface, within roadway fill over the levee crown.					
FS Date: 5/22/2013

Pipes visible on LS next to roadway.

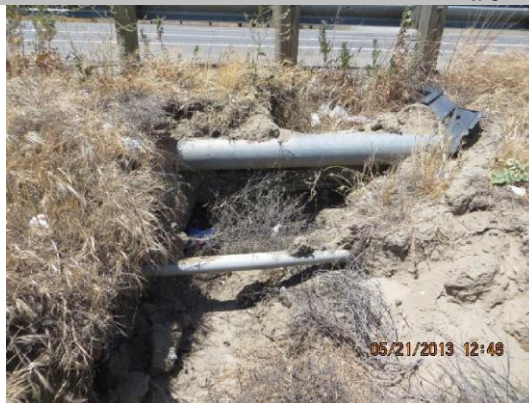
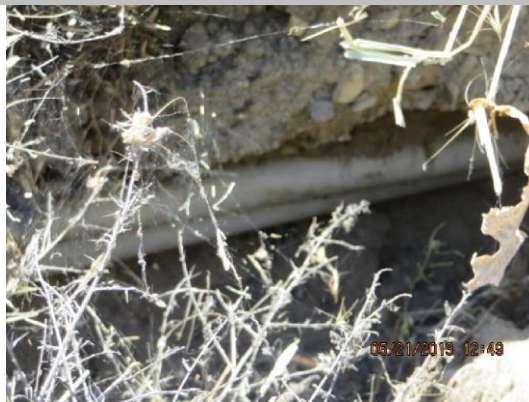
LM Start	0.23	Rating **	M	Issue No.	27
LM End	0.23	Issue Type +	En	Location *	
Category	Supplemental			GPS Latitude/Longitude	
				Start	End
Item	DWR UCIP Field Study			37.784586 °	37.784586 °
				-121.306837 °	-121.306837 °
DWR ID	23110				
Comment Code					
Inspector Comment					
FS_ID:15174					
DS_ID:23110					
EP_NO: N/A					
Repair Type: Non-Urgent					
Crossing Status: Found					
UCIP Comments: No permit identified for this crossing.					
FIELD_STRUCT_DESC: 1.5-inch polyvinyl chloride (PVC) conduit of an unknown purpose, 1 foot below the road surface, within roadway fill over the levee crown.					
FS Date: 5/22/2013

Pipes visible on LS next to roadway.

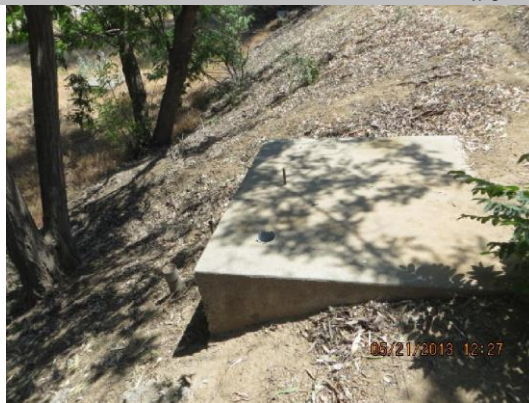
Photo 1 of 1 : UCIP_SP_2019_16188_27296.jpg

LM Start	0.27	Rating **	M	Issue No.	28
LM End	0.27	Issue Type +	En	Location *	
Category	Supplemental			GPS Latitude/Longitude	
				Start	End
Item	DWR UCIP Field Study			37.784194 °	37.784194 °
				-121.306353 °	-121.306353 °
DWR ID	19055				
Comment Code					
Inspector Comment					
FS_ID:16188 DS_ID:19055 EP_NO: 12101B Repair Type: Non-Urgent Crossing Status: Found UCIP Comments: Appears abandoned and should be done so properly. FIELD_STRUCT_DESC: 4" electrical conduit through the levee 2.5 feet below the crown. Distribution panel on a 5-foot by 6-foot concrete pad on the WS shoulder (Permit No 12101B, 1979). FS Date: 5/21/2013

5X5 concrete pad with exposed electrical conduit on WS shoulder.

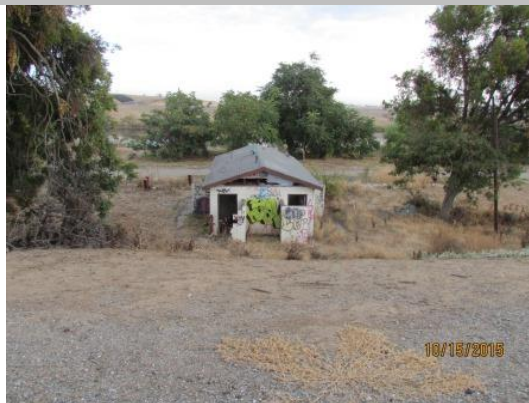
Photo 1 of 1 : SP_2019_RD2107_329_20_20190313_00006.jpg

LM Start	0.32	Rating **	M	Issue No.	20
LM End	0.32	Issue Type +	En	Location *	WS
Category	Earthen Levee			GPS Latitude/Longitude	
				Start	End
Item	Encroachments			37.783649 °	37.783649 °
				-121.305710 °	-121.305710 °
DWR ID	DWR_RD2107_01_f_2015_20				
Comment Code					
BU : Building					
Inspector Comment					
Building in the floodway may impede flood flows.

View of the building in the floodway.

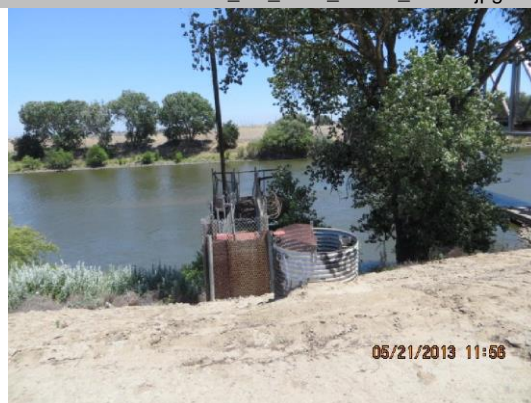
Photo 1 of 3 : UCIP_SP_2019_13684_22411.jpg

Comment Code					
Inspector Comment					
FS_ID:13684					
DS_ID:19036					
EP_NO: N/A					
Repair Type: Non-Urgent					
Crossing Status: Found					
UCIP Comments: Wooden walkway to pump on platform is in disrepair and may be a hazard.					
FIELD_STRUCT_DESC: 1 of 2: 14-inch irrigation pipe of an unknown material through the levee, 17 feet below the crown. Pump on pile structure in the stream. Walkway to pump. Slide gate in a 48-inch corrugated metal pipe (CMP) riser on the waterside (WS) shoulder. 36-inch concrete standpipe at the landside (LS) toe. Service pole and circuit panel on the LS toe. [Additional Reference(s): DWR Levee Log, 2005. USACE San Joaquin O&M Manual 9, April 1964, (HLM 0.68), 12-inch pipe listed].					
FS Date: 5/21/2013

Pier and 48-inch CMP riser on WS shoulder

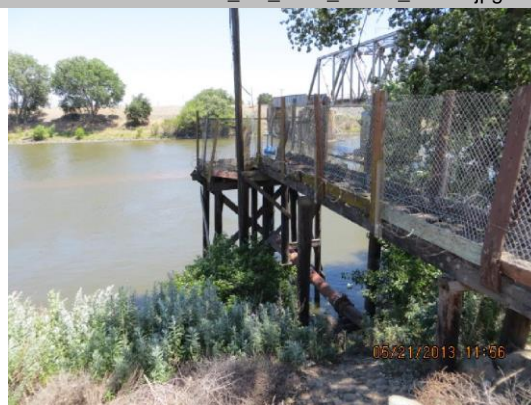
Photo 2 of 3 : UCIP_SP_2019_13684_22410.jpg

Walkway to pump on pier at WS.

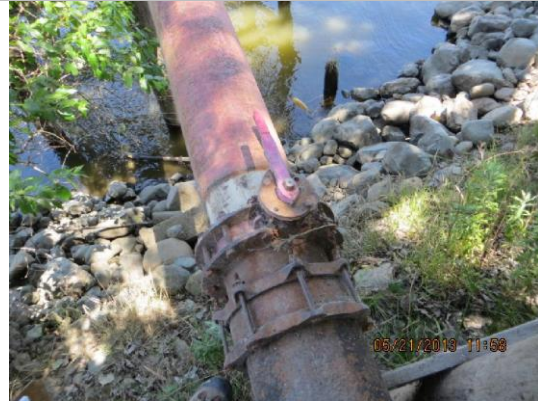
Photo 3 of 3 : UCIP_SP_2019_13684_22409.jpg

Comment Code						
Inspector Comment						
FS_ID:13684 DS_ID:19036 EP_NO: N/A Repair Type: Non-Urgent Crossing Status: Found UCIP Comments: Wooden walkway to pump on platform is in disrepair and may be a hazard. FIELD_STRUCT_DESC: 1 of 2: 14-inch irrigation pipe of an unknown material through the levee, 17 feet below the crown. Pump on pile structure in the stream. Walkway to pump. Slide gate in a 48-inch corrugated metal pipe (CMP) riser on the waterside (WS) shoulder. 36-inch concrete standpipe at the landside (LS) toe. Service pole and circuit panel on the LS toe. [Additional Reference(s): DWR Levee Log, 2005. USACE San Joaquin O&M Manual 9, April 1964, (HLM 0.68), 12-inch pipe listed]. FS Date: 5/21/2013

Butterfly valve on WS toe.

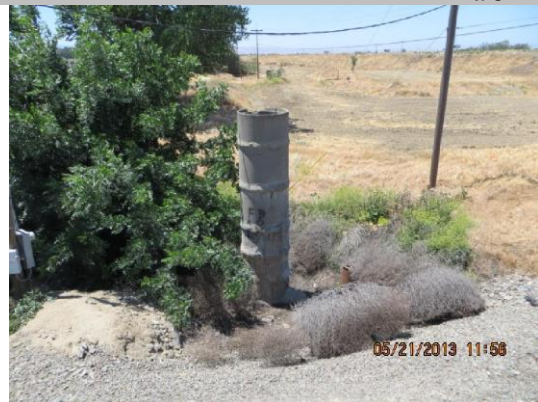
Photo 1 of 2 : UCIP_SP_2019_13883_22821.jpg

Comment Code					
Inspector Comment					
FS_ID:13883					
DS_ID:19039					
EP_NO: N/A					
Repair Type: Non-Urgent					
Crossing Status: Found					
UCIP Comments: Slide gate missing actuator inside 55-inch CMP riser.					
FIELD_STRUCT_DESC: 14-inch irrigation pipe of an unknown material					
through the levee, 15 feet below the crown. Pipe likely runs from a 36-					
inch concrete standpipe on the landside (LS) to outlet on the waterside					
(WS) toe. Portion of the discharge line from the pump at Levee Mile

36-inch concrete standpipe on LS toe.

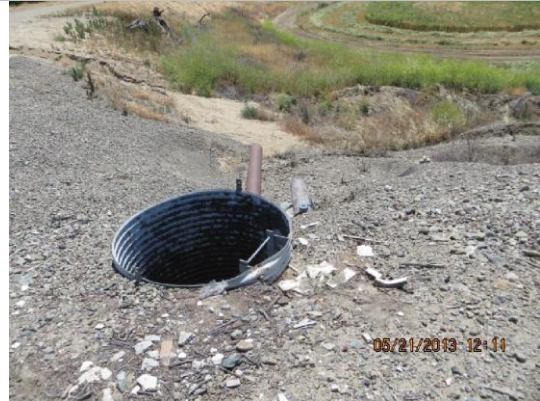
Photo 2 of 2 : UCIP_SP_2019_13883_22822.jpg

Comment Code						
Inspector Comment						
FS_ID:13883 DS_ID:19039 EP_NO: N/A Repair Type: Non-Urgent Crossing Status: Found UCIP Comments: Slide gate missing actuator inside 55-inch CMP riser. FIELD_STRUCT_DESC: 14-inch irrigation pipe of an unknown material through the levee, 15 feet below the crown. Pipe likely runs from a 36-inch concrete standpipe on the landside (LS) to outlet on the waterside (WS) toe. Portion of the discharge line from the pump at Levee Mile 0.68. 55-inch corrugated metal pipe (CMP) riser with slide gate on the LS shoulder. [Additional Reference(s): DWR Levee Log, 2005. USACE San Joaquin O&M Manual 9, April 1964, (HLM 0.71)]. FS Date: 5/21/2013

55-inch CMP riser with slide gate (no handle) on LS shoulder. 14-inch and 12-inch pipe visible on LS toe.

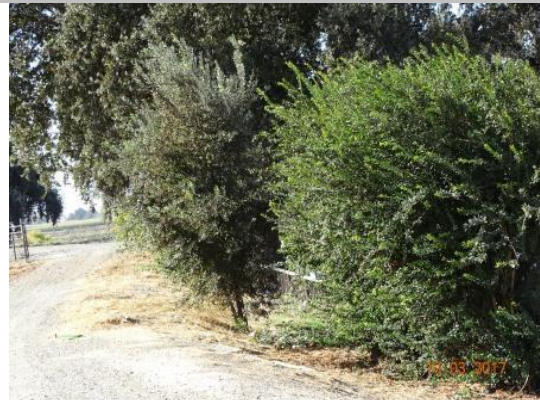
Photo 1 of 1 : SP_2019_RD2107_329_17_20190313_00004.jpg

LM Start	1.23	Rating **	M	Issue No.	17
LM End	1.23	Issue Type +	En	Location *	LS
Category	Earthen Levee			GPS Latitude/Longitude	
				Start	End
Item	Vegetation			37.774123 °	37.774123 °
				-121.307189 °	-121.307189 °
DWR ID	DWR_RD2107_01_s_2012_17				
Comment Code					
V6 : Landscaping					
Inspector Comment					
Landscaping and a fence are present on the levee slope.

View of landscape planted on the landside levee slope and a 3-ft yard fence at the levee toe.

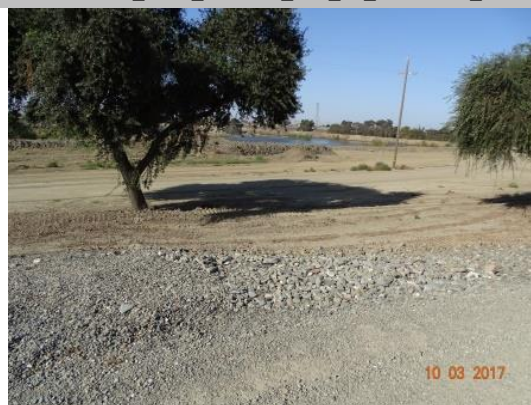
Photo 1 of 1 : SP_2019_RD2107_329_15_20190313_00003.jpg

LM Start	1.34	Rating **	A/W	Issue No.	15
LM End	1.34	Issue Type +	Ob	Location *	
Category	Supplemental			GPS Latitude/Longitude	
				Start	End
Item	2017 Storm Damage			37.772704 °	37.772704 °
				-121.306793 °	-121.306793 °
DWR ID	DWR_RD2107_01_f_2017_15				
Comment Code					
Inspector Comment					
Levee Evaluation Comments					
Description:					
Site ID No:111					
Site Designation:208-4					
Repair Type: Seepage					
Rating:					
Field Date:					
Notes: In 1997 there was heavy seepage at this location. In 2017 there was no seepage observed at this location.

View of the historic seepage site.

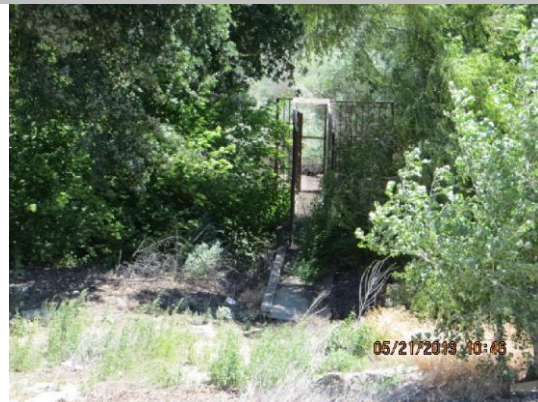
Photo 1 of 3 : UCIP_SP_2019_13650_22341.jpg

LM Start	1.47	Rating **	M	Issue No.	32
LM End	1.47	Issue Type +	En	Location *	
Category	Supplemental			GPS Latitude/Longitude	
				Start	End
Item	DWR UCIP Field Study			37.771735 °	37.771735 °
				-121.304847 °	-121.304847 °
DWR ID	19040				
Comment Code					
Inspector Comment					
FS_ID:13650 DS_ID:19040 EP_NO: N/A Repair Type: Non-Urgent Crossing Status: Found UCIP Comments: No pump. Appears abandoned. Large hole under pipe on WS slope from animal activity. FIELD_STRUCT_DESC: 1 of 2: 18-inch polyvinyl chloride (PVC) irrigation pipe through the levee, 2.5 feet below the crown. Pump on pile structure in the stream. Walkway to the pump. [Additional Reference(s): DWR Levee Log, 2005. USACE San Joaquin O&M Manual 9, April 1964, (HLM 1.49)]. FS Date: 5/21/2013

Pumping plant on metal pier on WS toe.

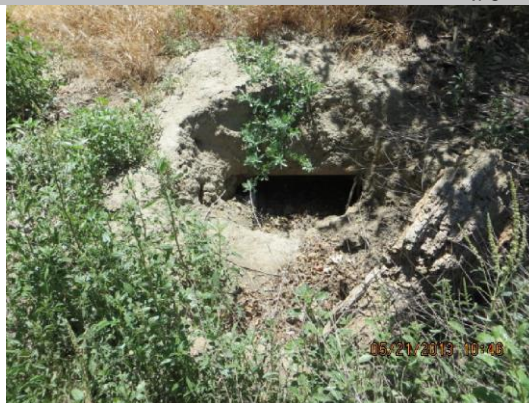
Photo 2 of 3 : UCIP_SP_2019_13650_22340.jpg

LM Start	1.47	Rating **	M	Issue No.	32 (cont)
LM End	1.47	Issue Type +	En	Location *	
Category	Supplemental			GPS Latitude/Longitude	
				Start	End
Item	DWR UCIP Field Study			37.771735 °	37.771735 °
				-121.304847 °	-121.304847 °
DWR ID	19040				
Comment Code					
Inspector Comment					
FS_ID:13650 DS_ID:19040 EP_NO: N/A Repair Type: Non-Urgent Crossing Status: Found UCIP Comments: No pump. Appears abandoned. Large hole under pipe on WS slope from animal activity. FIELD_STRUCT_DESC: 1 of 2: 18-inch polyvinyl chloride (PVC) irrigation pipe through the levee, 2.5 feet below the crown. Pump on pile structure in the stream. Walkway to the pump. [Additional Reference(s): DWR Levee Log, 2005. USACE San Joaquin O&M Manual 9, April 1964, (HLM 1.49)]. FS Date: 5/21/2013

Large hole under pipe on WS slope.

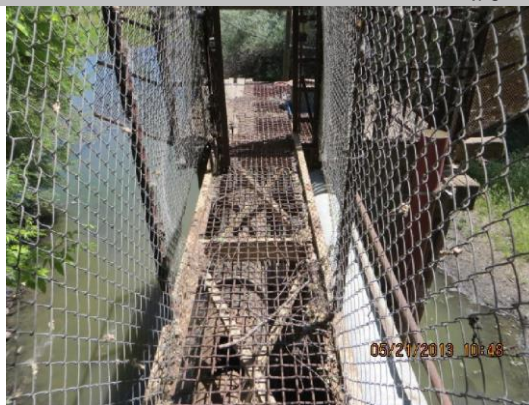
Photo 3 of 3 : UCIP_SP_2019_13650_22339.jpg

Pumping plant on metal pier on WS toe. Pipe visible on right under walkway.

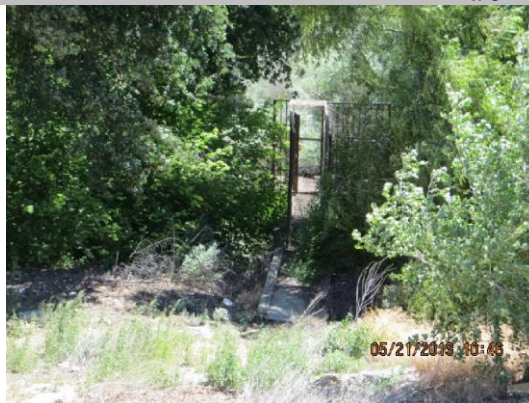
Photo 1 of 3 : UCIP_SP_2019_15179_24935.jpg

LM Start	1.47	Rating **	M	Issue No.	33	
LM End	1.47	Issue Type +	En	Location *		
Category	Supplemental			GPS Latitude/Longitude		
				Start	End	
Item	DWR UCIP Field Study			37.771735 °	37.771735 °	
				-121.304847 °	-121.304847 °	
DWR ID	23106					
Comment Code						
Inspector Comment						
FS_ID:15179 DS_ID:23106 EP_NO: N/A Repair Type: Non-Urgent Crossing Status: Found UCIP Comments: Pipe open on WS toe at the pump on pier. Pipe abandoned and should be done so properly. FIELD_STRUCT_DESC: 16-inch steel irrigation pipe through the levee, 2.5 feet below the crown. Pump on pile structure in the stream. Walkway to the pump. FS Date: 5/21/2013

Metal pier on WS slope.

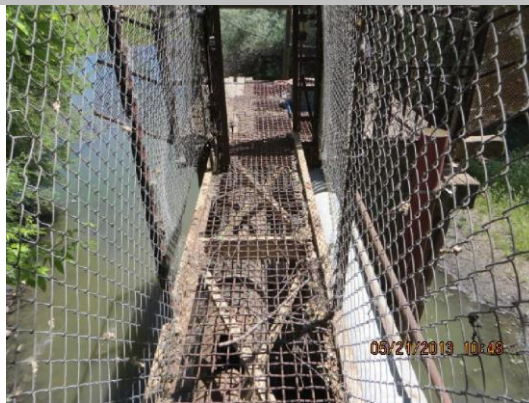
Photo 2 of 3 : UCIP_SP_2019_15179_24934.jpg

Pipe visible under metal walkway on WS slope.

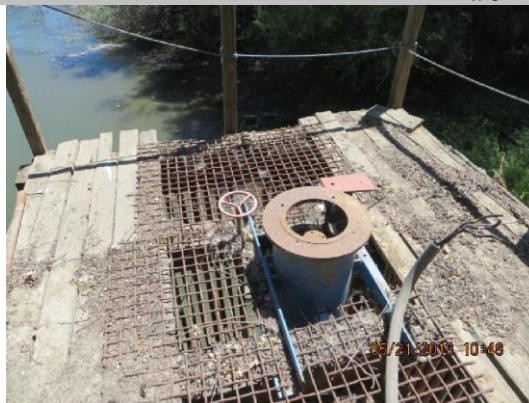
Photo 3 of 3 : UCIP_SP_2019_15179_24933.jpg

LM Start	1.47	Rating **	M	Issue No.	33 (cont)	
LM End	1.47	Issue Type +	En	Location *		
Category	Supplemental			GPS Latitude/Longitude		
				Start	End	
Item	DWR UCIP Field Study			37.771735 °	37.771735 °	
				-121.304847 °	-121.304847 °	
DWR ID	23106					
Comment Code						
Inspector Comment						
FS_ID:15179						
DS_ID:23106						
EP_NO: N/A						
Repair Type: Non-Urgent						
Crossing Status: Found						
UCIP Comments: Pipe open on WS toe at the pump on pier. Pipe abandoned and should be done so properly.						
FIELD_STRUCT_DESC: 16-inch steel irrigation pipe through the levee, 2.5 feet below the crown. Pump on pile structure in the stream.						
Walkway to the pump.						
FS Date: 5/21/2013

Pipe open at pump on platform on WS.

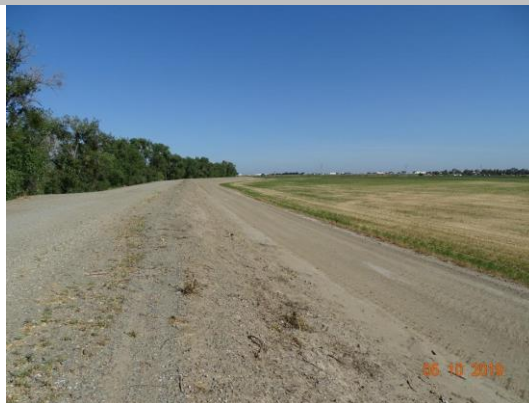
Photo 1 of 1 : SP_2019_RD2107_330_4_20190514_00010.jpg

Typical view of vegetation on landside slope. (Spring 2019)

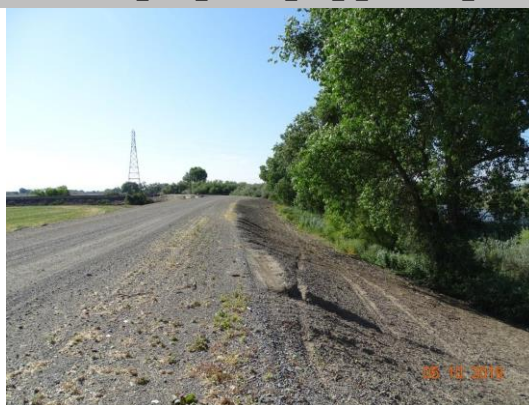
Photo 1 of 1 : SP_2019_RD2107_330_5_20190514_00009.jpg

LM Start	0.01	Rating **	A	Issue No.	5
LM End	1.13	Issue Type +	Ma	Location *	WS
Category	Earthen Levee			GPS Latitude/Longitude	
				Start	End
Item	Vegetation			37.760693 °	37.770937 °
				-121.309589 °	-121.324302 °
DWR ID	DWR_RD2107_02_s_2019_5				
Comment Code					
Inspector Comment					
Annual vegetation is well maintained.

Typical view of vegetation on waterside slope. (Spring 2019)

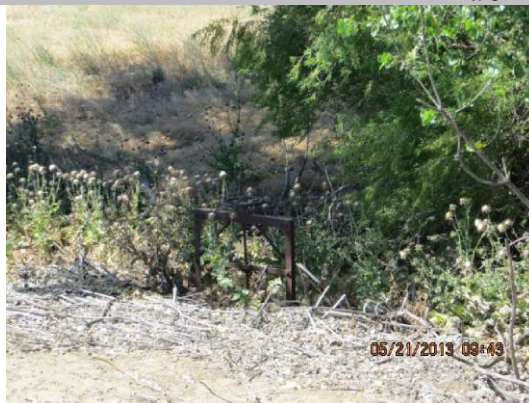
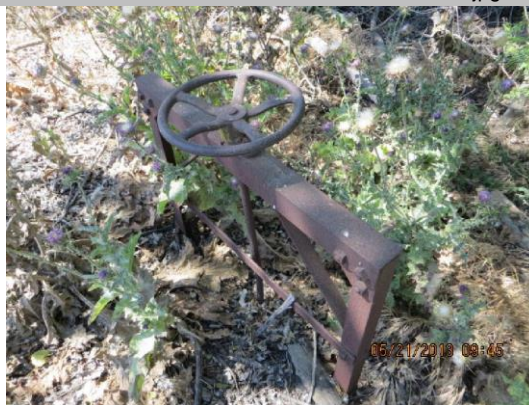
LM Start	0.27	Rating **	M	Issue No.	6	
LM End	0.27	Issue Type +	Ma	Location *		
Category	Supplemental			GPS Latitude/Longitude		
				Start	End	
Item	DWR UCIP LMA Responsibility			37.762613 °	37.762613 °	
				-121.313480 °	-121.313480 °	
DWR ID	19057					
Comment Code						
Inspector Comment						
FS_ID:13637						
DS_ID:19057						
EP_NO: N/A						
Repair Type: Non-Urgent						
Crossing Status: Found						
UCIP Comments: Pipe filled in with soil around outlet and not visible on						
LS. Appears abandoned and should be done so properly.						
FIELD_STRUCT_DESC: *ABANDONED* 16-inch steel drainage pipe,						
16 feet below the crown. Slide gate on the waterside (WS) toe.						
[Additional Reference(s): DWR Levee Log, 2005. USACE San Joaquin						
O&M Manual 9, April 1964, (HLM 0.27)].						
FS Date: 5/21/2013

Slide gate visible on WS toe.

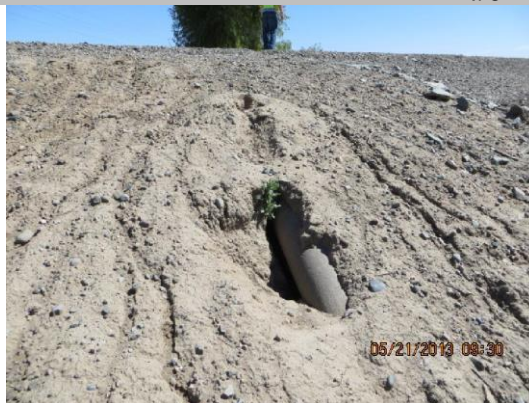
Photo 1 of 3 : UCIP_SP_2019_13636_22296.jpg

LM Start	0.54	Rating **	M	Issue No.	7	
LM End	0.54	Issue Type +	En	Location *		
Category	Supplemental			GPS Latitude/Longitude		
				Start		End
Item	DWR UCIP Field Study			37.764832 °		37.764832 °
				-121.317405 °		-121.317405 °
DWR ID	19058					
Comment Code						
Inspector Comment						
FS_ID:13636 DS_ID:19058 EP_NO: 13161 Repair Type: Non-Urgent Crossing Status: Found UCIP Comments: Some erosion along pipe alignment on WS slope. FIELD_STRUCT_DESC: 10-inch steel drainage pipe through the levee, 5 feet below the crown. Pump located on a 36-inch concrete standpipe at the landside (LS) toe. A polyvinyl chloride (PVC) pipe runs parallel to the waterside (WS) toe to the train tracks. Air relief valve on the WS shoulder. (Permit No. 13161, 1981 - [owner not indicated in permit database]). [Additional Reference(s): DWR Levee Log, 2005]. FS Date: 5/21/2013

Erosion along pipe alignment on WS slope.

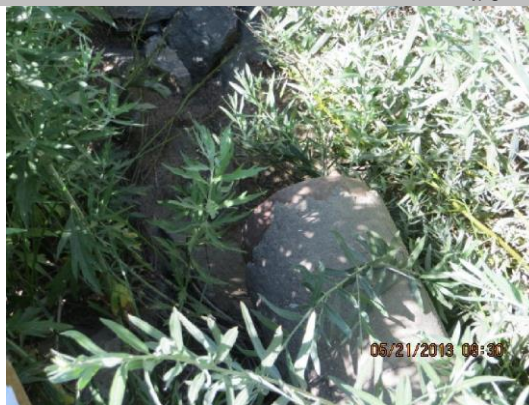
Photo 2 of 3 : UCIP_SP_2019_13636_22295.jpg

Pipe at outlet.

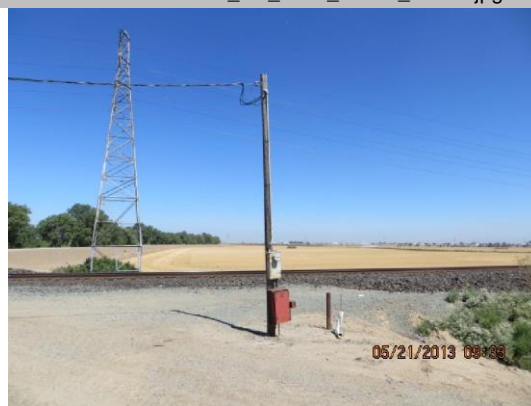
Photo 3 of 3 : UCIP_SP_2019_13636_22294.jpg

LM Start	0.54	Rating **	M	Issue No.	7 (cont)	
LM End	0.54	Issue Type +	En	Location *		
Category	Supplemental			GPS Latitude/Longitude		
				Start		End
Item	DWR UCIP Field Study			37.764832 °		37.764832 °
				-121.317405 °		-121.317405 °
DWR ID	19058					
Comment Code						
Inspector Comment						
FS_ID:13636 DS_ID:19058 EP_NO: 13161 Repair Type: Non-Urgent Crossing Status: Found UCIP Comments: Some erosion along pipe alignment on WS slope. FIELD_STRUCT_DESC: 10-inch steel drainage pipe through the levee, 5 feet below the crown. Pump located on a 36-inch concrete standpipe at the landside (LS) toe. A polyvinyl chloride (PVC) pipe runs parallel to the waterside (WS) toe to the train tracks. Air relief valve on the WS shoulder. (Permit No. 13161, 1981 - [owner not indicated in permit database]). [Additional Reference(s): DWR Levee Log, 2005]. FS Date: 5/21/2013

JP and meter on LS shoulder.

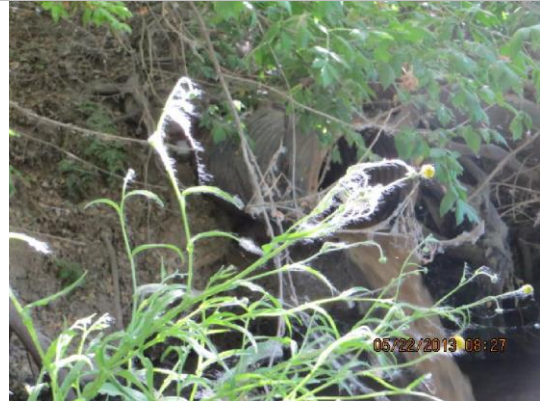
Photo 1 of 3 : UCIP_SP_2019_53388_22441.jpg

FS_ID:53388
DS_ID:19056
EP_NO: 2966
Repair Type: Urgent
Crossing Status: Found
UCIP Comments: 10/10/2018 A temporary flexible pvc pipe installed at this location. Although the levee looks to be in good condition, keeping Urgent due to the temporary nature of this pipe and the need for follow up due to potential levee threat (D. Sanoski - DWR UCIP).11/29/2017 Received update from DWR levee inspector M. Khashchuk and pipe is visible on WS toe with flap gate open: back filled during high winter flow to prevent erosion (no photos are available of back fill work). No updates were provided regarding repairs to the sink hole located on LS toe or internal inspection of pipe through the levee, pipe crossing remains urgent. (DWR UCIP - O. Magana)11/16/2016 Visible hole through pipe visible on WS end. Sink hole present at the LS ditch. Evidence of pipe repair visible on LS (see photos) however, no permit was found to document the work. Need to contact owner to determine permit authorizing work. Due to the hole in the pipe recommend internal inspection of the pipe through the levee to determine pipe integrity. (O. Magana - DWR UCIP)05/22/2013 Headwall around pipe at LS toe is failing and should be shored up. Flap gate propped open and should be returned to normal function. (W. Wylie - DWR UCIP)

Pipe visible on WS toe with Flap gate open.

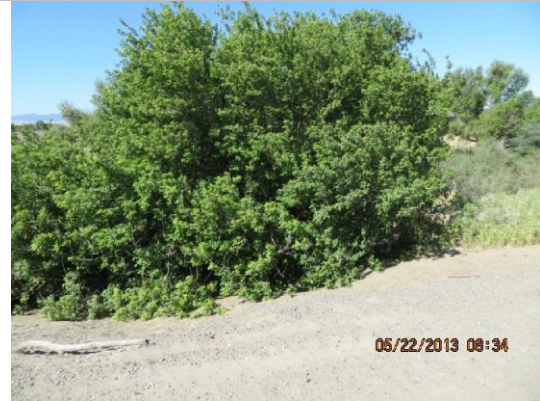
Photo 2 of 3 : UCIP_SP_2019_53388_22440.jpg

Comment Code						
Inspector Comment						
FS_ID:53388 DS_ID:19056 EP_NO: 2966 Repair Type: Urgent Crossing Status: Found UCIP Comments: 10/10/2018 A temporary flexible pvc pipe installed at this location. Although the levee looks to be in good condition, keeping Urgent due to the temporary nature of this pipe and the need for follow up due to potential levee threat (D. Sanoski - DWR UCIP).11/29/2017 Received update from DWR levee inspector M. Khashchuk and pipe is visible on WS toe with flap gate open: back filled during high winter flow to prevent erosion (no photos are available of back fill work). No updates were provided regarding repairs to the sink hole located on LS toe or internal inspection of pipe through the levee, pipe crossing remains urgent. (DWR UCIP - O. Magana)11/16/2016 Visible hole through pipe visible on WS end. Sink hole present at the LS ditch. Evidence of pipe repair visible on LS (see photos) however, no permit was found to document the work. Need to contact owner to determine permit authorizing work. Due to the hole in the pipe recommend internal inspection of the pipe through the levee to determine pipe integrity. (O. Magana - DWR UCIP)05/22/2013 Headwall around pipe at LS toe is failing and should be shored up. Flap gate propped open and should be returned to normal function. (W. Wylie - DWR UCIP) FIELD_STRUCT_DESC: 24-inch steel drainage pipe through the levee, 14 feet below the crown. Flap gate on the waterside (WS) end of the pipe. Two standard reinforced concrete cutoff walls around the pipe in line with the levee shoulders. (Permit No. 2966, 1958 - Dell'Ossso Brothers). FS Date: 10/10/2018 2:37:00 PM

Pipes visible under foliage on WS toe.

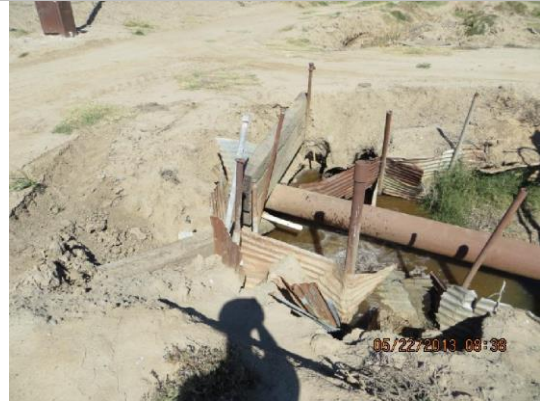
Photo 3 of 3 : UCIP_SP_2019_53388_22439.jpg

Comment Code						
Inspector Comment						
FS_ID:53388 DS_ID:19056 EP_NO: 2966 Repair Type: Urgent Crossing Status: Found UCIP Comments: 10/10/2018 A temporary flexible pvc pipe installed at this location. Although the levee looks to be in good condition, keeping Urgent due to the temporary nature of this pipe and the need for follow up due to potential levee threat (D. Sanoski - DWR UCIP).11/29/2017 Received update from DWR levee inspector M. Khashchuk and pipe is visible on WS toe with flap gate open: back filled during high winter flow to prevent erosion (no photos are available of back fill work). No updates were provided regarding repairs to the sink hole located on LS toe or internal inspection of pipe through the levee, pipe crossing remains urgent. (DWR UCIP - O. Magana)11/16/2016 Visible hole through pipe visible on WS end. Sink hole present at the LS ditch. Evidence of pipe repair visible on LS (see photos) however, no permit was found to document the work. Need to contact owner to determine permit authorizing work. Due to the hole in the pipe recommend internal inspection of the pipe through the levee to determine pipe integrity. (O. Magana - DWR UCIP)05/22/2013 Headwall around pipe at LS toe is failing and should be shored up. Flap gate propped open and should be returned to normal function. (W. Wylie - DWR UCIP) FIELD_STRUCT_DESC: 24-inch steel drainage pipe through the levee, 14 feet below the crown. Flap gate on the waterside (WS) end of the pipe. Two standard reinforced concrete cutoff walls around the pipe in line with the levee shoulders. (Permit No. 2966, 1958 - Dell'Oso Brothers). FS Date: 10/10/2018 2:37:00 PM

Headwall failing at drainage ditch on LS toe.
